## **APPENDIX G**

### **DPR Forms**

State of California — The Resources Agency  
DEPARTMENT OF PARKS AND RECREATION  
**PRIMARY RECORD**

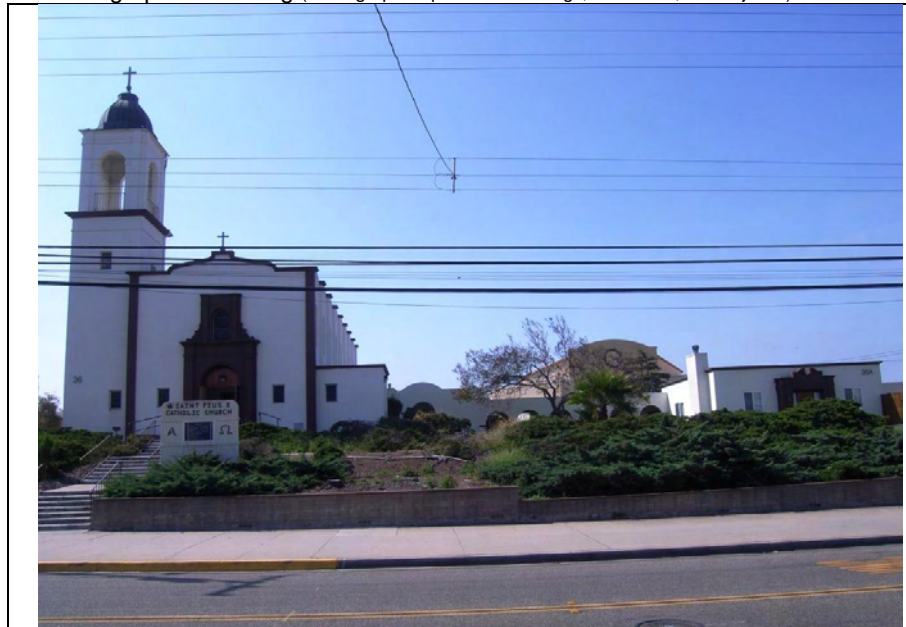
View looking west at the building.

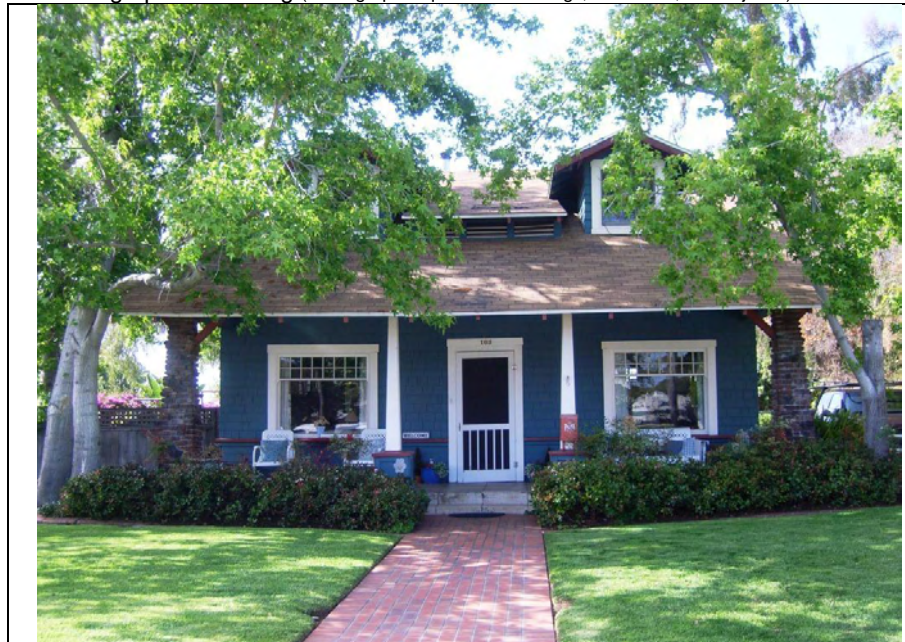
View looking north at the building.

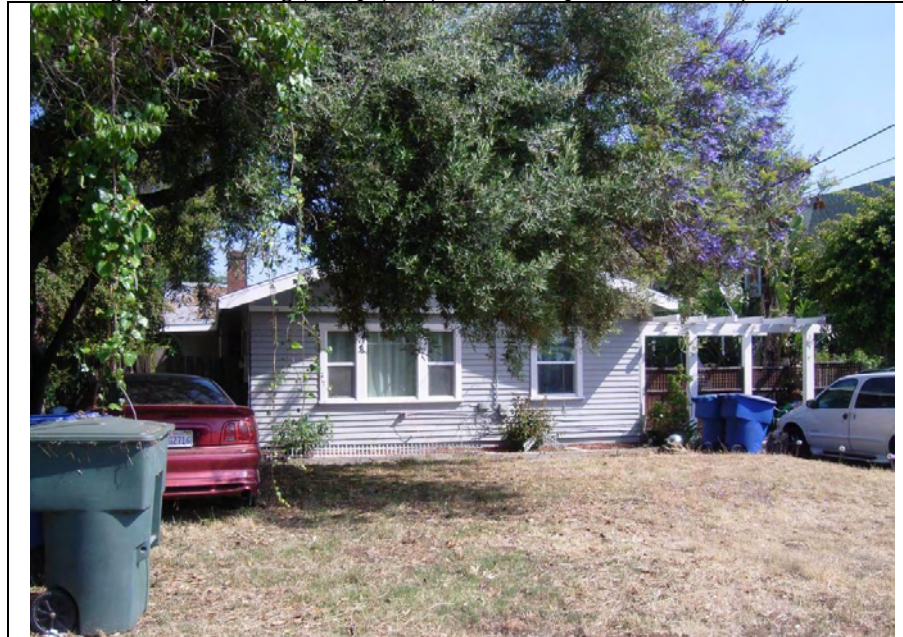
317 D Street was constructed in 1914 in the Craftsman style. It is a one-story single family residential building located on the north side of D Street. The residence has a wood frame, rectangular floor plan with a concrete foundation. The exterior is clad in a wood clapboard siding. The roof is a widely-pitched side gable roof with widely-overhanging and clad in an asphalt roll. The primary entrance is located on the east elevation. A pergola carport extends over the side driveway. The windows consist of vinyl sash windows. There is a vent underneath the gable end. There is one chimney located within the roof surface. Additions include a rear side gable addition. Modifications to the building include the replacement of windows and doors. Landscape features include a mature tree and a front yard with grass.

View looking north at the building.

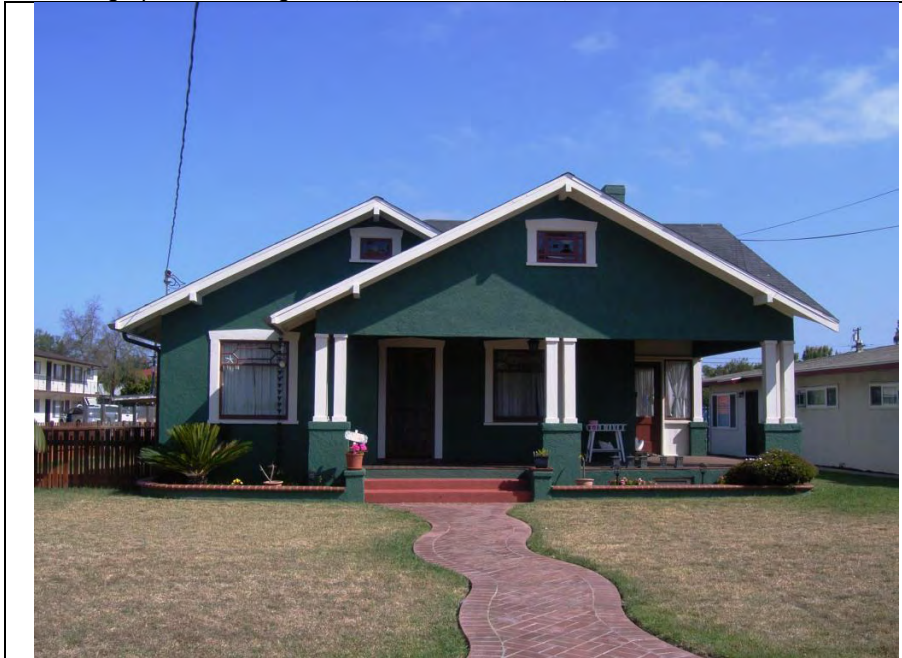
541 D Street was constructed circa 1925 in the Craftsman style. It is a one- and one-half story single family residential building located on the north side of D Street east of Broadway. The residence has a wood frame, rectangular floor plan with a concrete foundation. The exterior is clad in stucco siding. The roof is a moderately-pitched front and side gable roof with overhanging eaves with exposed purlins and clad in a composition roll. On the south elevation, a brick walkway and concrete steps lead to a wraparound recessed porch. Double squared columns sitting atop stucco piers support the porch roof. The primary entrance is located within the porch and consists of a single wood door. The secondary entrance is also located within the porch. The windows consist of fixed wood windows with decorative transoms. There is a chimney within the roof surface. There appear to be no modifications to the building. Landscape features include a front yard with a brick walkway. Also on the property lot is a multi-family building.

View looking north at the building.

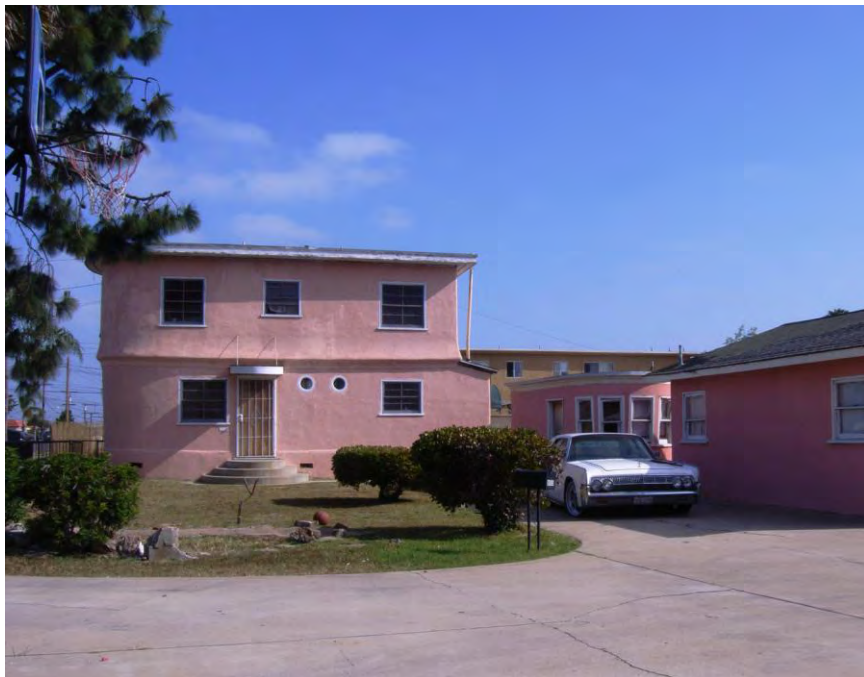
655 D Street was constructed c. 1940-1950 in the Streamline Moderne style. It is a two-story single family residential building located on the east side of Oaklawn Avenue. The residence has a wood and steel frame, curved floor plan with a concrete foundation. The exterior is clad in stucco siding. The roof is flat with a streamline cornice. On the south elevation, curved concrete steps lead to a stoop and a streamline hood. The primary entrance is located within the porch and is covered by a metal security door. The windows consist of double hung wood sash and porthole windows. Landscape features include a grass lawn and concrete driveway. There are three ancillary buildings located on the property, including one garage.

View looking north at the buildings.

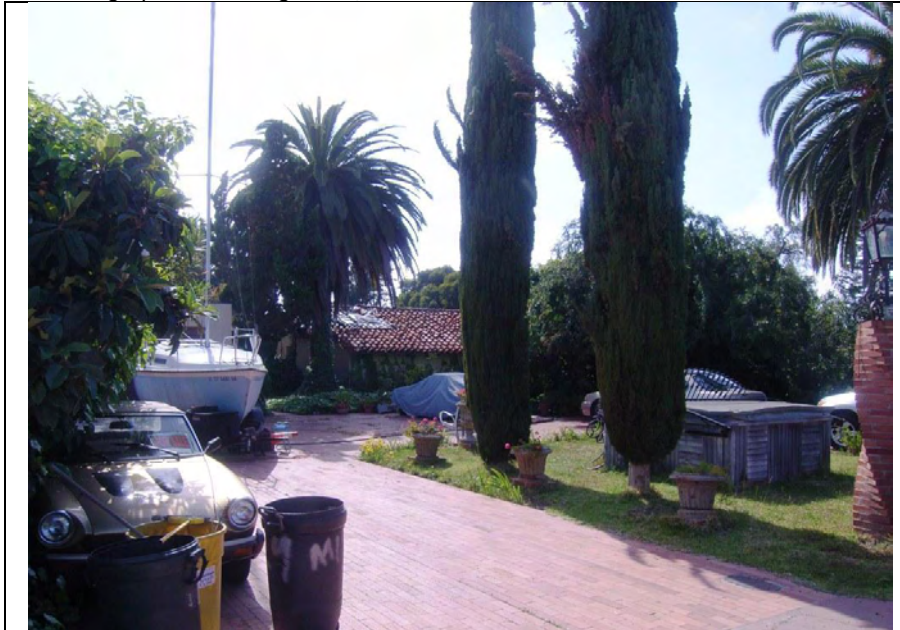
30 Del Mar Avenue was constructed in 1928 in the Mediterranean Revival style. It is a one-story single family residential building located on the west side of Del Mar Avenue. The residence has a wood frame, L-shaped floor plan with a concrete foundation. The exterior is clad in stucco siding. The roof is a moderately-pitched front and side gable roof with red clay tiles. No other features could be seen from the street at the time of the survey. Landscape features include a pool at the rear of the building, a brick driveway with mature trees and a grass lawn. There is a detached two-car garage on the property.

View looking west at the building.

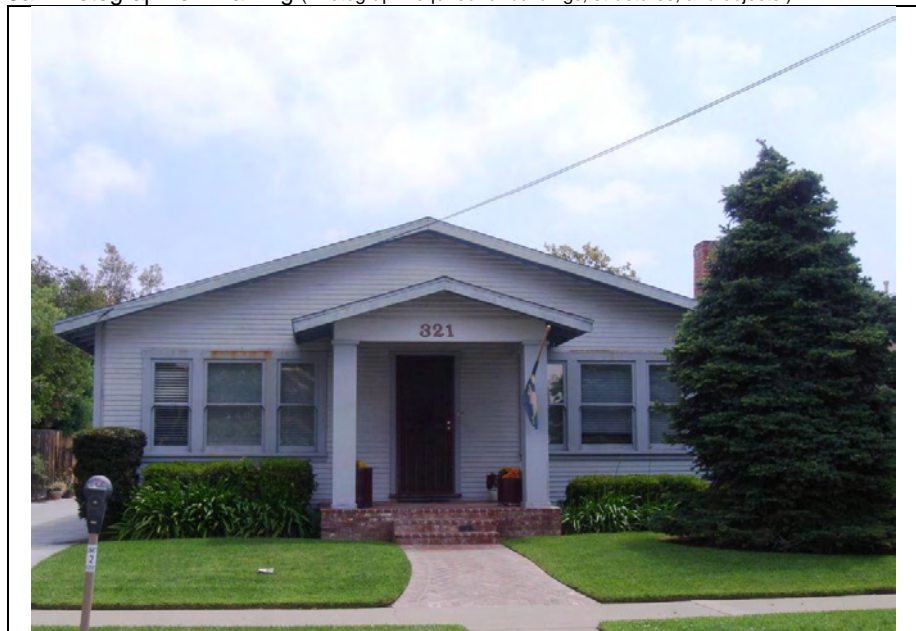
321 Del Mar Avenue was constructed circa 1925 in the Craftsman style. It is a one-story single family residential building located on the east side of Del Mar Avenue between F and Cypress streets. The residence has a wood frame, rectangular floor plan with a concrete foundation. The exterior is clad in horizontal wood board siding. The roof is a widely-pitched front gable roof with widely-overhanging eaves and clad in asphalt. On the west elevation, a brick walkway and steps lead to a partial-width porch with a front gable roof. The primary entrance is located within the porch and consists of a single wood door. The windows consist of double hung sash windows. There is a rear two-story addition. There is one chimney located on the south elevation exterior lateral. Landscape features include a front yard with a flowerbed and a side driveway.

View looking east at the building.

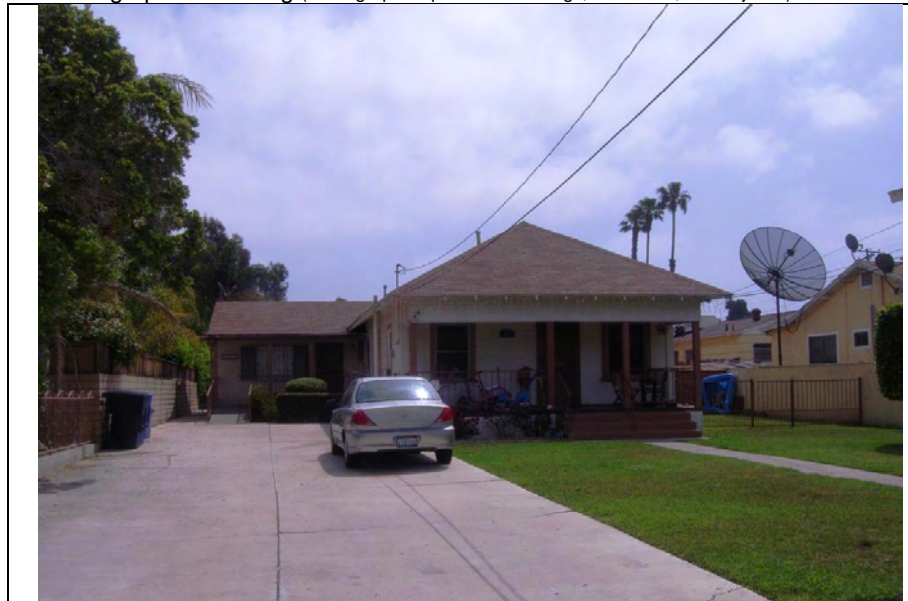
693 Del Mar Avenue was constructed in 1930 in the Craftsman style. It is a one-story single family residential building located on the east side of Del Mar Avenue between I and J streets. The residence has a wood frame, L-shaped floor plan with a concrete foundation. The exterior is clad in wood clapboard siding. The roof is a widely-pitched hipped roof with overhanging eaves and clad in an asphalt roll. On the west elevation, a concrete walkway and steps lead to a full-width recessed porch. Squared posts support the porch roof and a metal railing surrounds the porch. The primary entrance is located within the porch and consists of a single wood door. The windows consist of double hung wood sash windows. Modifications include the porch railing. Landscape features include a front and side grass lawn with a side concrete driveway.

View looking east at the building.

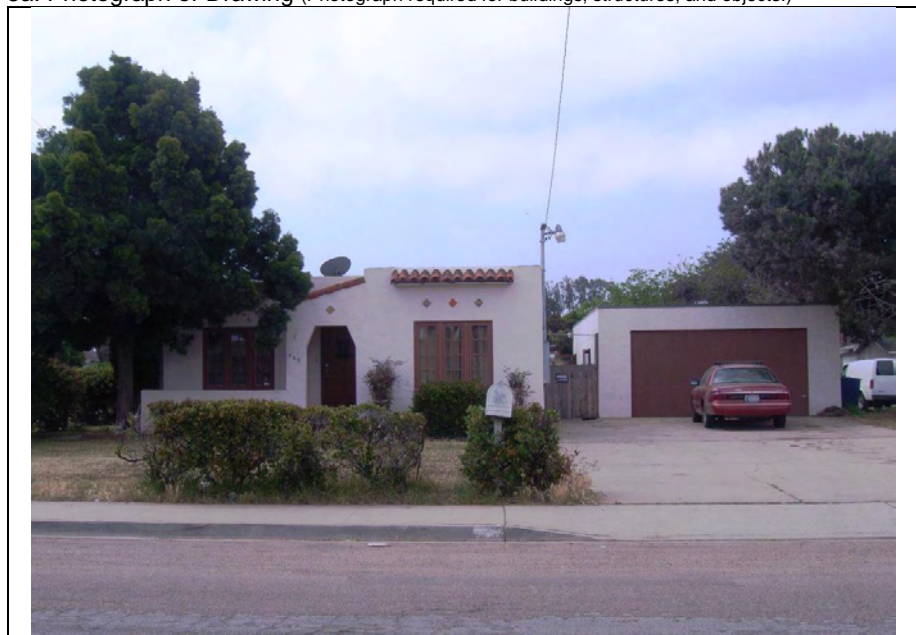
753 Dorothy Street was constructed circa 1930 in the Spanish Colonial Revival style. It is a one-story single family residential building located on the south side of Dorothy Street. The residence has a wood frame, rectangular floor plan with a concrete foundation. The exterior is clad in stucco siding. The roof is a flat roof with a raised parapet. On the north elevation, a concrete walkway leads to a recessed partial-width porch with a shed roof clad in red clay tiles. There is an open patio located on the front elevation next to the porch. The primary entrance is located within the porch and consists of a single wood door. The windows consist of wood casement windows. There is also a two-car garage located on the parcel. Other ornamental features of the building include tile medallions and a non-structural hood with red tile coping. Landscape features include a front yard, mature trees and a driveway.

View looking south at the building.

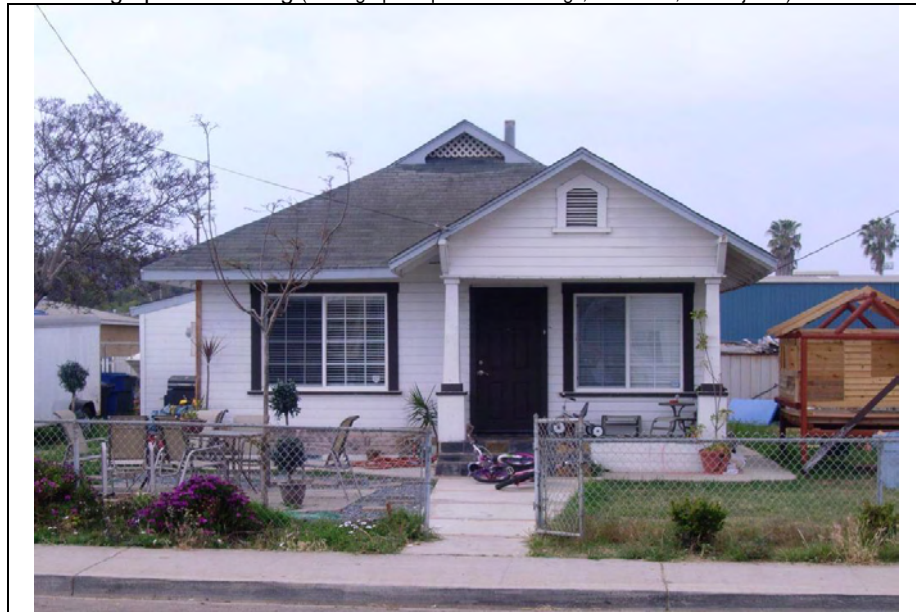
805 Dorothy Street was constructed in 1910 in the Craftsman style. It is a one-story building located on the south side of Dorothy Street between Industrial Boulevard and Frontage Road. The residence has a wood frame, rectangular floor plan with a concrete foundation. The exterior is clad in wood clapboard siding. The roof is a gable-on-hip roof. On the north elevation, a concrete walkway leads to a partial-width porch with a front gable roof. Tapered wood columns support the porch roof. The primary entrance is located within the porch and consists of a paneled wood door. The windows consist of multi-light vinyl sliding windows. Modifications to the building include the replacement of windows and doors. Landscape features include a front lawn and chain-link fence surrounding the property.

View looking south at the building.

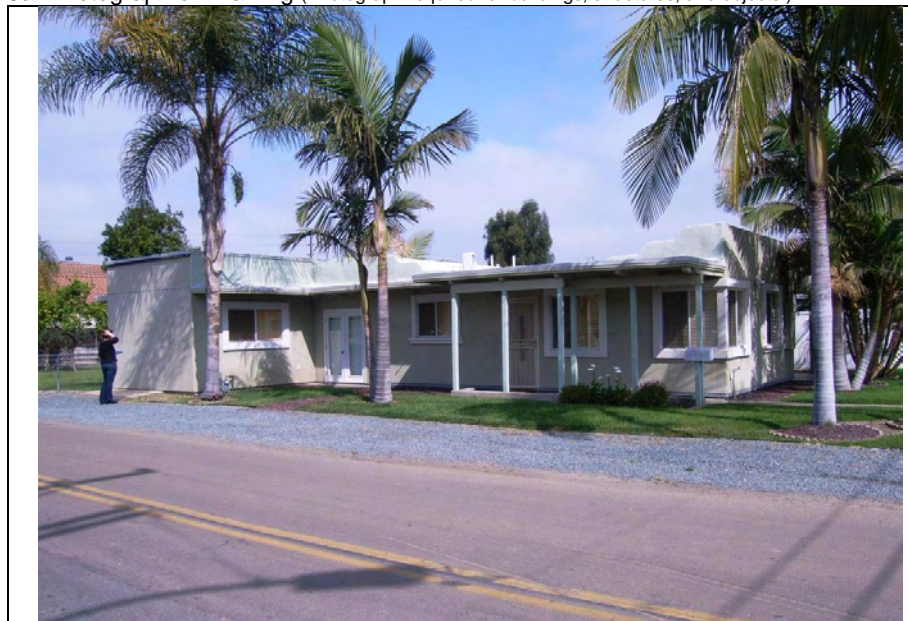
P5a. Photograph or Drawing (Photograph required for buildings, structures, and objects.)

1146 Elm Avenue was constructed in 1946 in the Streamline Moderne style. It is a one-story single family residential building located on the northwest side of Elm Avenue and Emerson Street. The residence has a wood frame, L-shaped floor plan with a concrete foundation. The exterior is clad in stucco siding. The roof is flat with a raised and shaped parapet. On the south elevation, a concrete walkway leads to a partial-width porch with a flat roof. The primary entrance is located within the porch and consists of a single wood door obscured by a metal security door. The windows consist of vinyl sliding windows with wide casings. Flat hoods with stepped banding surmount the windows and doors on the south and west facades. Additions include a one-story flat roof section on the west elevation. Modifications to the building include the replacement of windows. Landscape features include a grass lawn, mature trees and fencing at the rear of the building.

View looking north at the building.

1146 ELM AV is recommended eligible as a Chula Vista Historic Resource under NRHP, CRHR and local criteria. In considering the building within the historic context prepared for this survey, it does not appear to be associated with any significant themes or patterns in history and therefore not eligible for Criteria A or 1. Additionally, no significant persons were identified in association with the property and it is not recommended eligible under Criteria B or 2. 1146 ELM AV as an excellent local example of the Streamline Moderne style, and as such is recommended eligible as a Chula Vista Historic Resource under Criterion 3. Character defining features of the Streamline Moderne style include the curved wall surface, stucco walls, flat roof with a raised parapet and flat hood. Following the same reasons, it is also eligible for the California Register of Historical Resources and National Register of Historic Places, on the local level, under Criterion 3 (CRHR) and Criterion C (NRHP). The building retains a significant degree of its building materials dating to the period of significance, especially in comparison to other similar properties. Overall it retains a high degree of integrity, especially of design, materials, and craftsmanship.

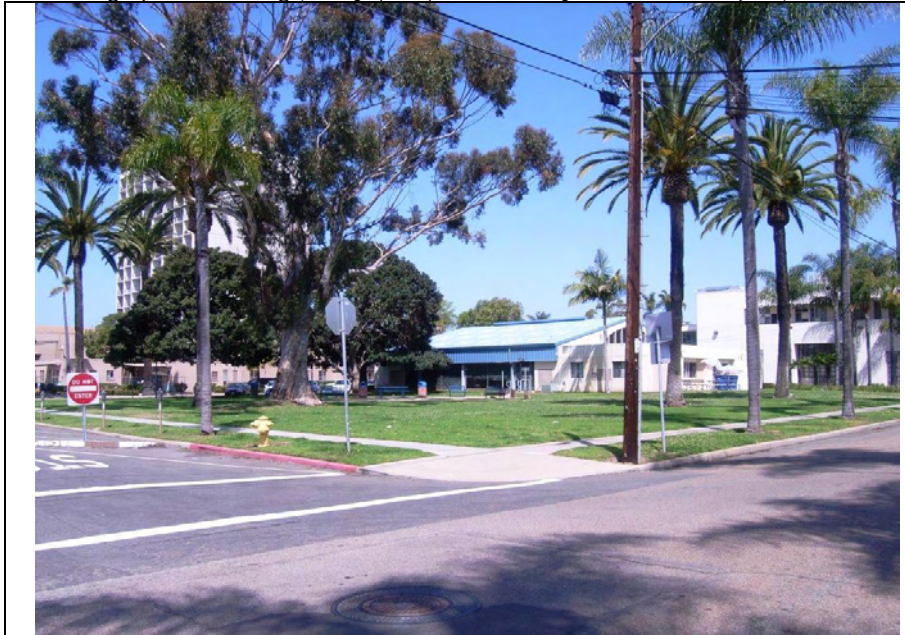
P5a. Photograph or Drawing (Photograph required for buildings, structures, and objects.)

View looking northwest at the park.

270 F ST is not recommended eligible as a Chula Vista Historic Resource under any NRHP or CRHR or local criteria. In considering the building within the historic context prepared for this survey, it does not appear to be associated with any significant themes or patterns in history and therefore not eligible for Criteria A or 1. Additionally, no significant persons or events were identified in association with the property and it is not eligible under Criteria B or 2. Because 270 F ST does not possess features of a particular architectural style, it is not a good representative of any architectural style and is not eligible under Criteria C or 3. The original park was constructed in 1916 as the first city park, however, the park remains only 1/4 of its original size and therefore does not retain enough integrity to be eligible as a landscape under local Criterion 4.

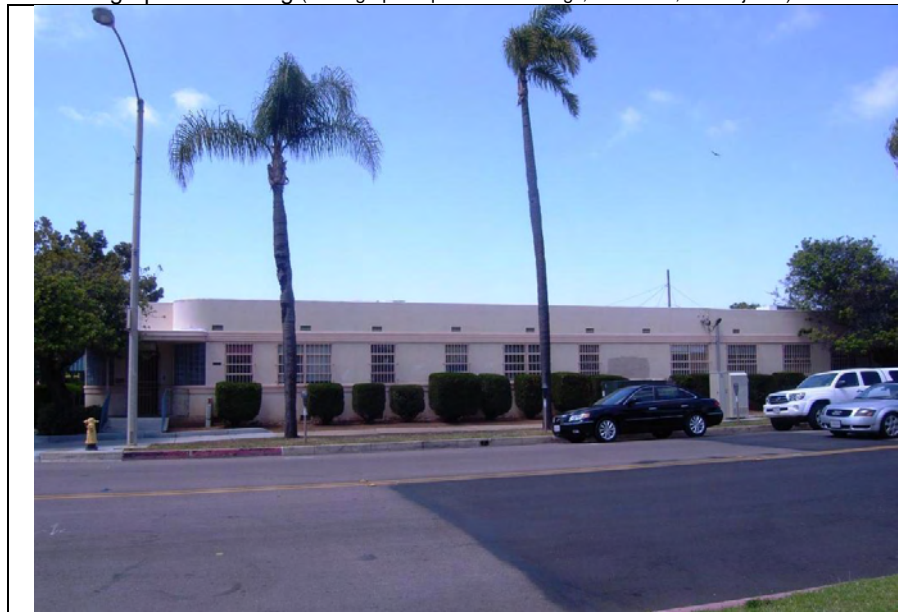
P5a. Photograph or Drawing (Photograph required for buildings, structures, and objects.)

275 F Street was constructed in 1947 in the Streamline Moderne style. It is a one-story commercial building located on the north side of F Street between Del Mar and Church avenues. The commercial building has a wood frame, rectangular floor plan with a concrete foundation. The exterior is clad in stucco siding. The roof is a flat roof with a raised parapet. On the south elevation, a concrete walkway leads to a partial-width recessed porch. The primary entrance is located within the porch and consists of a single wood door with metal security bars. The windows consist of glass block sidelight and hopper windows. Landscape features include mature trees and a row of bushes on the south elevation.

View looking north at the building.

275 F ST is recommended eligible as a Chula Vista Historic Resource under NRHP, CRHR and local criteria. In considering the building within the historic context prepared for this survey, it does not appear to be associated with any significant themes or patterns in history and therefore not eligible for Criteria A or 1. Additionally, no significant persons were identified in association with the property and it is not recommended eligible under Criteria B or 2. 275 F ST as an excellent local example of the Streamline Moderne style, and as such is recommended eligible as a Chula Vista Historic Resource under Criterion 3. Character defining features of the Streamline Moderne style include the curved corners on exterior walls, smooth stucco wall surface, emphasis on horizontal orientation, asymmetrical façade and a curved hood over the entry way. Following the same reasons, it is also eligible for the California Register of Historical Resources and National Register of Historic Places, on the local level, under Criterion 3 (CRHR) and Criterion C (NRHP). The building retains a significant degree of its building materials dating to the period of significance, especially in comparison to other similar properties. Overall it retains a high degree of integrity, especially of design, materials, and craftsmanship.

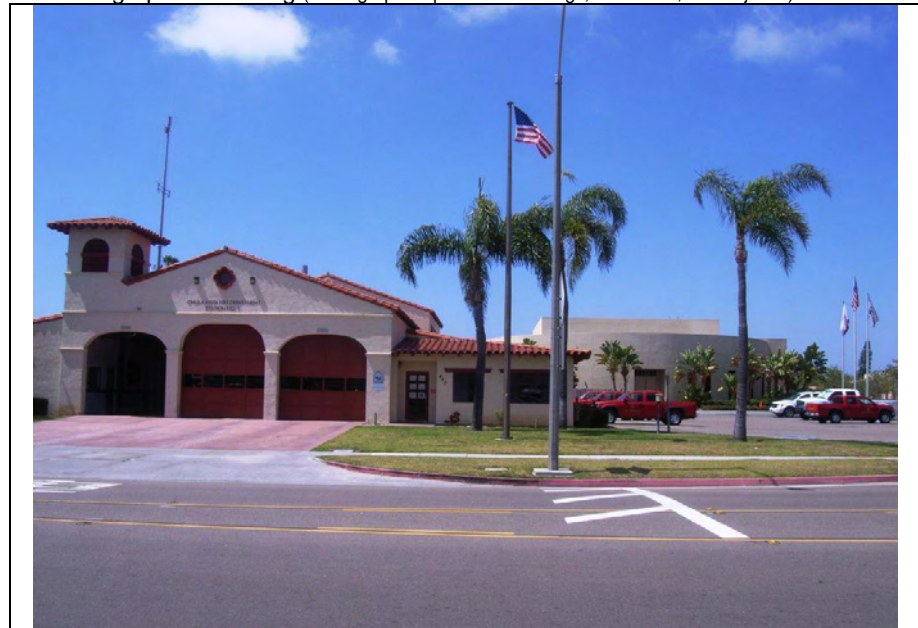
P5a. Photograph or Drawing (Photograph required for buildings, structures, and objects.)

447 F Street was constructed in 1948 in the Spanish Colonial Revival style. It is a two story fire station building located on the north side of F Street. The fire station has a wood frame, rectangular floor plan with a concrete foundation. The exterior is clad in stucco siding with horizontal bands on the wall surface. The roof is a moderately-pitched front-gable roof with shallow eaves and clad in red clay tiles. On the south elevation, there is a driveway which leads to three large garage doors which accommodate the fire engines. The primary entrance is located on the south elevation and consists of a single wood door with partial glazing. The windows consist of fixed plate glass windows. There is a large square turret on the southwest side of the building with a low-pitched pyramidal roof covered in red clay tiles. Other ornamental features include the quatrefoil medallion underneath the apex gable. Modifications to the building include the replacement of some windows. Landscape features include a flagpole, a grass lawn and some palm trees.

View looking north at the building.

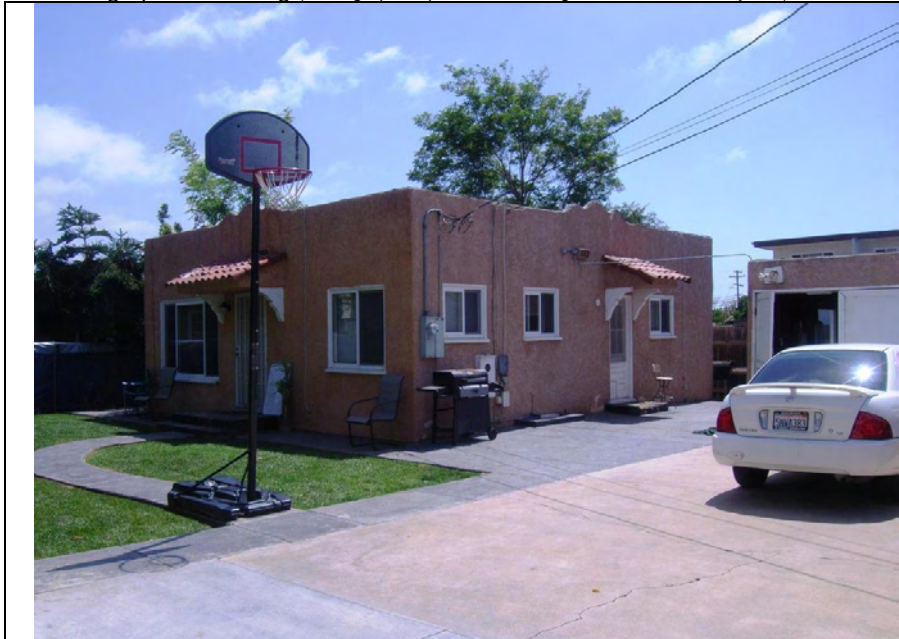
P5a. Photograph or Drawing (Photograph required for buildings, structures, and objects.)

480 F Street was constructed in 1930 in the Spanish Colonial Revival style. It is a one-story single family residential building located on the south side of F Street. The residence has a wood frame, rectangular floor plan with a concrete foundation. The exterior is clad in stucco siding. The roof is flat with a raised parapet. On the east elevation, a concrete walkway and steps lead to a covered stoop with a hood. The primary entrance is located within the stoop and consists of a single wood door. The windows consist of vinyl sliding and sash windows. Modifications to the building include the replacement siding and windows. Landscape features include a front lawn, some trees and a side concrete driveway.

View looking southwest of the building.

480 F ST is not recommended eligible as a Chula Vista Historic Resource under any NRHP or CRHR or local criteria. In considering the building within the historic context prepared for this survey, it does not appear to be associated with any significant themes or patterns in history and therefore not eligible for Criteria A or 1. Additionally, no significant persons were identified in association with the property and it is not recommended eligible under Criteria B or 2. Although 480 F ST possesses some stylistic features of the Spanish Colonial Revival style, it is not a good representative of the style and is not recommended eligible under Criteria C or 3.

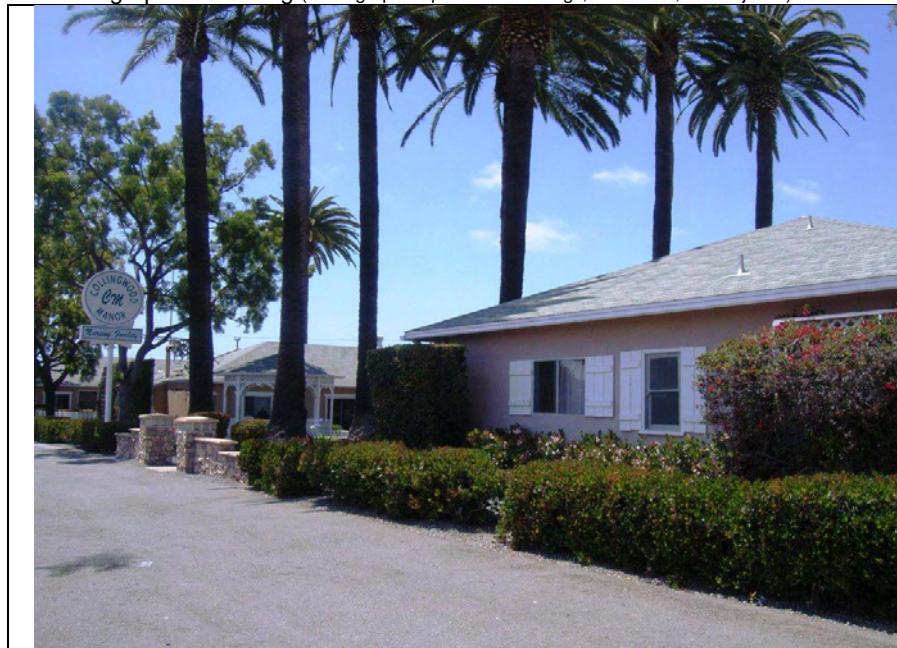
P5a. Photograph or Drawing (Photograph required for buildings, structures, and objects.)

553 F Street was constructed in 1952 in the Modern style. It is a one-story multi-family residential nursing home located on the north side of F Street between Beech and Ash avenues. The nursing home has a wood frame, complex floor plan with a concrete foundation. The exterior is clad in stucco siding. The roof is a moderately-pitched front and side gable roof with shallow eaves and clad in an asphalt roll. On the south elevation, a concrete walkway leads to a recessed porch. The primary entrance is located within the porch and could not be seen from the street at the time of the survey. There are two open courtyards that consist of a grass lawn and mature trees. The windows consist of aluminum sliding windows. The residential entrances face the interior courtyards. There is a sign on a lamppost which reads, "Collingwood Manor Nursing Facility."

View looking north at the building.

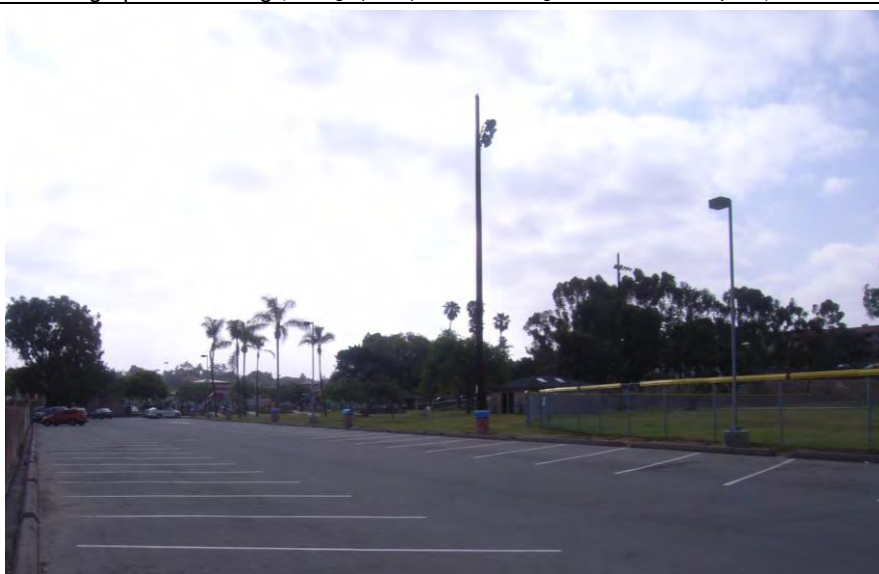
P5a. Photograph or Drawing (Photograph required for buildings, structures, and objects.)

View looking east at the building.

EUCALYPTUS PARK is recommended eligible as a Chula Vista Historic Resource under NRHP, CRHR and local criteria. In considering the building within the historic context prepared for this survey, is recommended eligible as a Chula Vista Historic Resource under Criterion 1 for its association with Chula Vista's Community Planning and Development during the City Development and City Maturation periods. Following the same reasons, it is also eligible for the California Register of Historical Resources and National Register of Historic Places, on the local level, under Criterion 1 (CRHR) and Criterion A (NRHP) under the area of significance of Community Planning and Development. No significant persons were identified in association with the property and it is not recommended eligible under Criteria B or 2. Because EUCALYPTUS PARK does not possess any features of a particular architectural style, it is not recommended eligible under local Criteria 3. EUCALYPTUS PARK is an important historic landscape in Chula Vista that is and was used as a recreation area since its construction in 1926 and therefore is recommended eligible under local criterion 4, CRHR Criterion 3, and NRHP Criterion C. The overall integrity of the property is high, especially in regard to location, setting and feeling.

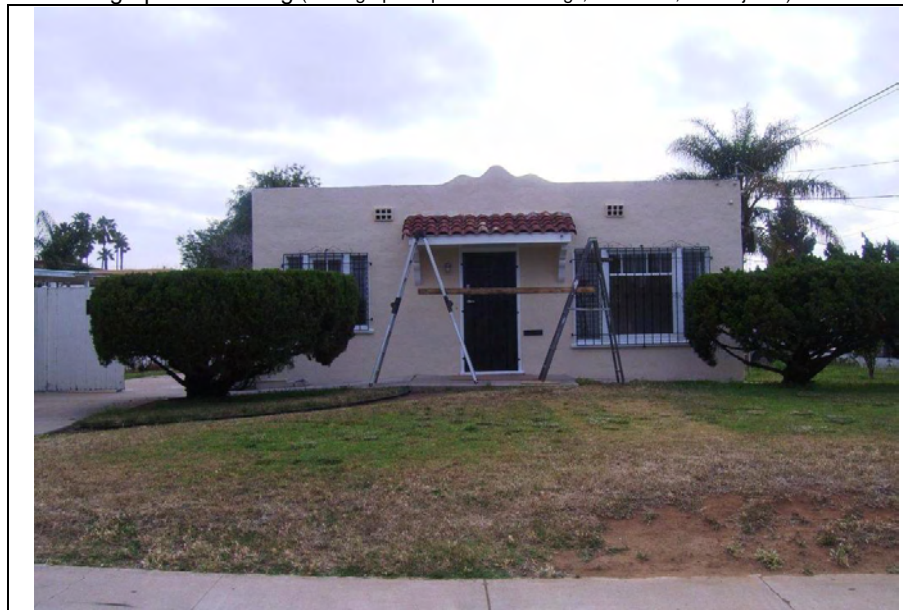
P5a. Photograph or Drawing (Photograph required for buildings, structures, and objects.)

319 Fifth Avenue was constructed circa 1925 in the Spanish Colonial Revival style. It is a one-story single family residential building located on the east side of Fifth Avenue, north of Center Street. The residence has a wood frame, rectangular floor plan with a concrete foundation. The exterior is clad in stucco siding. The roof is flat with a raised parapet. On the east elevation, a concrete walkway and step lead to a partial-width stoop with a hood. The hood is covered in red clay tiles. The primary entrance is located within the porch and consists of a wood door and obscured by a metal security door. The windows consist of tripartite fixed windows flanked by double hung wood sashes. There is a garage to the rear of the building. Landscape features include a front yard and a side driveway.

View looking east at the building.

319 FIFTH AV is not recommended eligible as a Chula Vista Historic Resource under any NRHP or CRHR or local criteria. In considering the building within the historic context prepared for this survey, it does not appear to be associated with any significant themes or patterns in history and therefore not eligible for Criteria A or 1. Rita Hayworth lived here in 1933 while working in Tijuana, however she lived at this address before she was famous, therefore this house is not a good example of that association and it is not recommended eligible under Criteria B or 2. Although 319 FIFTH AV possesses some stylistic features of the Spanish Colonial Revival style, it is not a good representative of the style and is not recommended eligible under Criteria C or 3. The building retains a significant degree of its building materials dating to the period of significance, especially in comparison to other similar properties. Overall it retains a high degree of integrity, especially of design, materials, and craftsmanship.

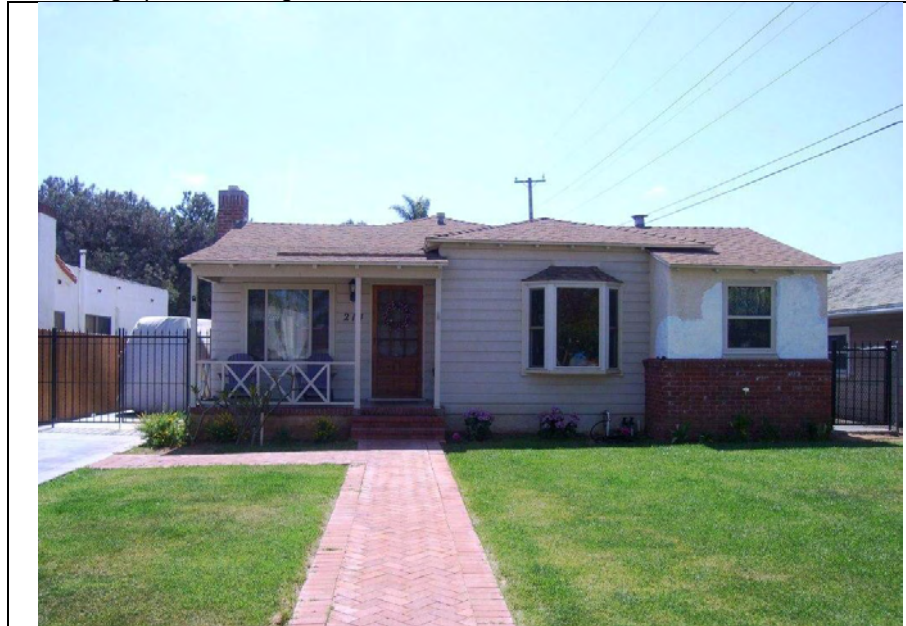
P5a. Photograph or Drawing (Photograph required for buildings, structures, and objects.)

214 Fig Avenue was constructed in 1940 in the Minimal Traditional style. It is a one-story single family residential building located on the west side of Fig Avenue. The residence has a wood frame, rectangular floor plan with a concrete foundation. The exterior is clad in channel drop wood siding. The roof is a widely-pitched side gable roof with pyramidal sections and clad in asphalt shingles. There are exposed rafter tails. On the east elevation, a brick walkway and steps lead to a partial-width porch with a shed roof. The primary entrance is located within the porch and consists of a wood door with lights. The windows consist of vinyl sash windows. There is also an angled bay window on the east facade. There is one chimney located on the south façade exterior lateral. Additions to the building include a one story addition on the north elevation that is clad in stucco and a lower brick wall veneer. Modifications to the building include the replacement of windows and doors. Landscape features include a front lawn and a side driveway with an iron gate leading to the rear of the parcel lot.

View looking west at the building.

214 FIG AV is not recommended eligible as a Chula Vista Historic Resource under any NRHP or CRHR or local criteria. In considering the building within the historic context prepared for this survey, it does not appear to be associated with any significant themes or patterns in history and therefore not eligible for Criteria A or 1. Additionally, no significant persons were identified in association with the property and it is not recommended eligible under Criteria B or 2. Although 214 FIG AV possesses some stylistic features of the Minimal Traditional style, it is not a good representative of the style and is not recommended eligible under Criteria C or 3.

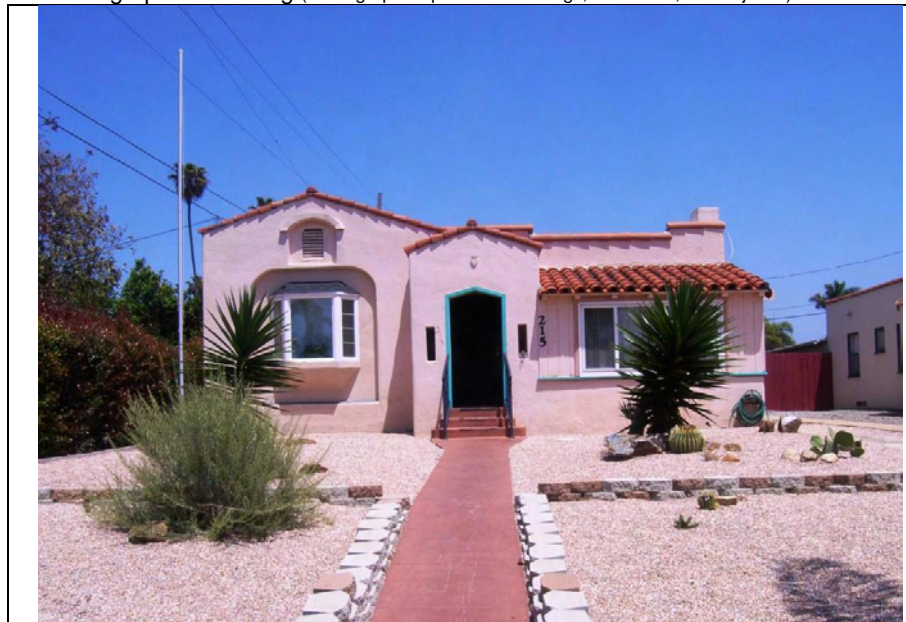
P5a. Photograph or Drawing (Photograph required for buildings, structures, and objects.)

215 Fig Avenue was constructed in 1929 in the Spanish Colonial Revival style. It is a one-story single family building located on the east side of Fig Avenue, south of E Street. The residence has a wood frame, rectangular floor plan with a concrete foundation. The exterior is clad in stucco siding. The roof is flat with a raised parapet and front gable projection covered in red clay tiles. On the west elevation, a concrete walkway and steps with a metal railing lead to a recessed partial-width porch. The primary entrance is located within the porch and consists of a single wood door. The windows consist of vinyl sash and aluminum sash windows. There is one chimney located on the south elevation exterior lateral. Modifications to the building include the enclosure of the porch on the main facade. Landscape features include a gravel yard with cacti and a small brick wall surrounding the property.

View looking east at the building.

215 FIG AV is not recommended eligible as a Chula Vista Historic Resource under any NRHP or CRHR or local criteria. In considering the building within the historic context prepared for this survey, it does not appear to be associated with any significant themes or patterns in history and therefore not eligible for Criteria A or 1. Additionally, no significant persons were identified in association with the property and it is not recommended eligible under Criteria B or 2. Although 215 FIG AV possesses stylistic features of the Spanish Colonial Revival style, it is not a good representative of the style due to loss of integrity (specifically the enclosure of the front porch) and in comparison with other local examples of the style. As such, 215 FIG AV is not recommended eligible under Criteria C or 3.

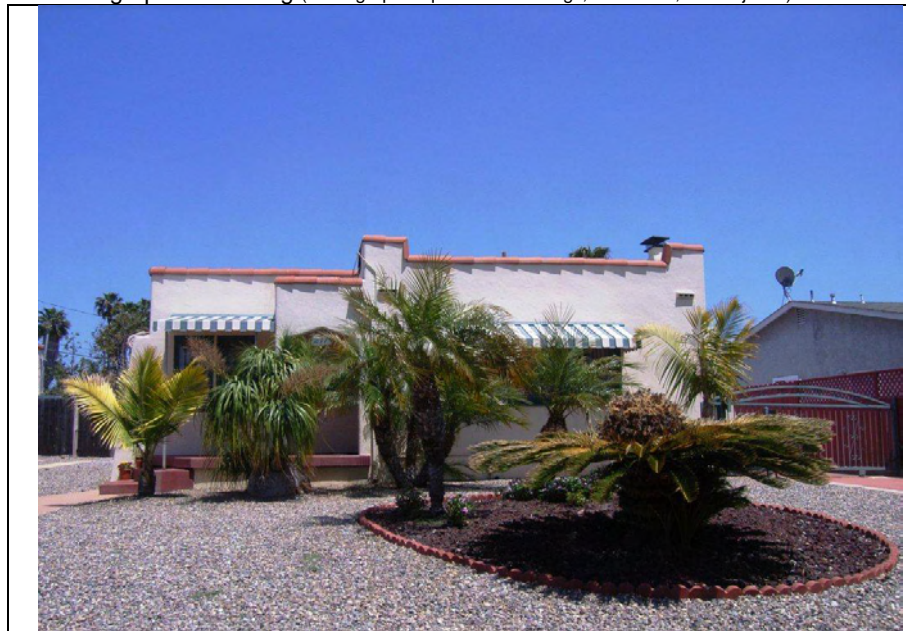
P5a. Photograph or Drawing (Photograph required for buildings, structures, and objects.)

217 Fig Avenue was constructed in 1930 in the Spanish Colonial Revival style. It is a one-story single family residential building located on the east side of Fig Avenue, north of Davidson Street. The residence has a wood frame, rectangular floor plan with a concrete foundation. The exterior is clad in stucco siding. The roof is flat with a raised parapet and red clay tile coping. A concrete walkway and steps lead to a partial-width porch with a metal awning roof and a corner covered porch. There is a winged wall on the west elevation. The primary entrance is located within the porch and consists of a single wood door. The windows consist of double hung wood sash windows. There is a shed-roof projection covered in red clay tiles. There is also a chimney on the south elevation. Modifications to the building include the metal awnings over the front porch and front window. Landscape features include a gravel yard with mulch island planting beds interspersed.

View looking east at the building.

217 FIG AV is recommended eligible as a Chula Vista Historic Resource under NRHP, CRHR and local criteria. In considering the building within the historic context prepared for this survey, it does not appear to be associated with any significant themes or patterns in history and therefore not eligible for Criteria A or 1. Additionally, no significant persons were identified in association with the property and it is not recommended eligible under Criteria B or 2. 217 FIG AV as an excellent local example of the Spanish Colonial Revival style, and as such is recommended eligible as a Chula Vista Historic Resource under Criterion 3. Character defining features of the Spanish Colonial Revival style include the smooth stucco walls. Following the same reasons, it is also eligible for the California Register of Historical Resources and National Register of Historic Places, on the local level, under Criterion 3 (CRHR) and Criterion C (NRHP). The building retains a significant degree of its building materials dating to the period of significance, especially in comparison to other similar properties. Overall it retains a high degree of integrity, especially of design, materials, and craftsmanship.

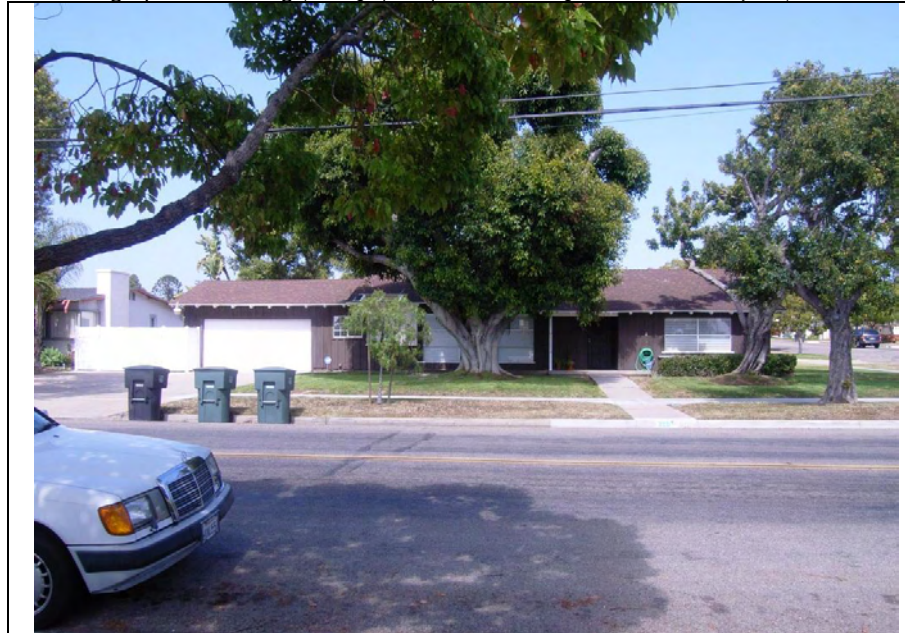
P5a. Photograph or Drawing (Photograph required for buildings, structures, and objects.)

395 First Avenue was constructed in 1954 in the Custom Ranch style. It is a one-story single family residential building located on the northeast side of First Avenue and G Street. The residence has a wood frame, rectangular floor plan with a concrete foundation. The exterior is clad in board-and-batten siding. The roof is a widely-pitched side gable roof with exposed rafter tails and clad in asphalt shingles. On the west elevation, a concrete walkway and step leads to a partial-width recessed porch. The primary entrance is located within the porch and consists of a single wood door. The windows consist of multi-light fixed windows. There is one chimney located within the roof surface. There is also a two car attached garage. Landscape features include mature trees and a front yard.

View looking east at the building.

395 FIRST AV is recommended eligible as a Chula Vista Historic Resource under NRHP, CRHR and local criteria. In considering the building within the historic context prepared for this survey, it does not appear to be associated with any significant themes or patterns in history and therefore not eligible for Criteria A or 1. Additionally, no significant persons were identified in association with the property and it is not recommended eligible under Criteria B or 2. City directories could not confirm when/if George Peppard and Helen Davies lived at the building. Additionally, there is some discrepancy about the date of construction. 395 FIRST AV as an excellent local example of the Custom Ranch style, and as such is recommended eligible as a Chula Vista Historic Resource under Criterion 3. Character defining features of the Custom Ranch style include the rambling floor plan, widely-pitched roof, and attached garage. Following the same reasons, it is also eligible for the California Register of Historical Resources and National Register of Historic Places, on the local level, under Criterion 3 (CRHR) and Criterion C (NRHP). The building retains a significant degree of its building materials dating to the period of significance, especially in comparison to other similar properties. Overall it retains a high degree of integrity, especially of design, materials, and craftsmanship.

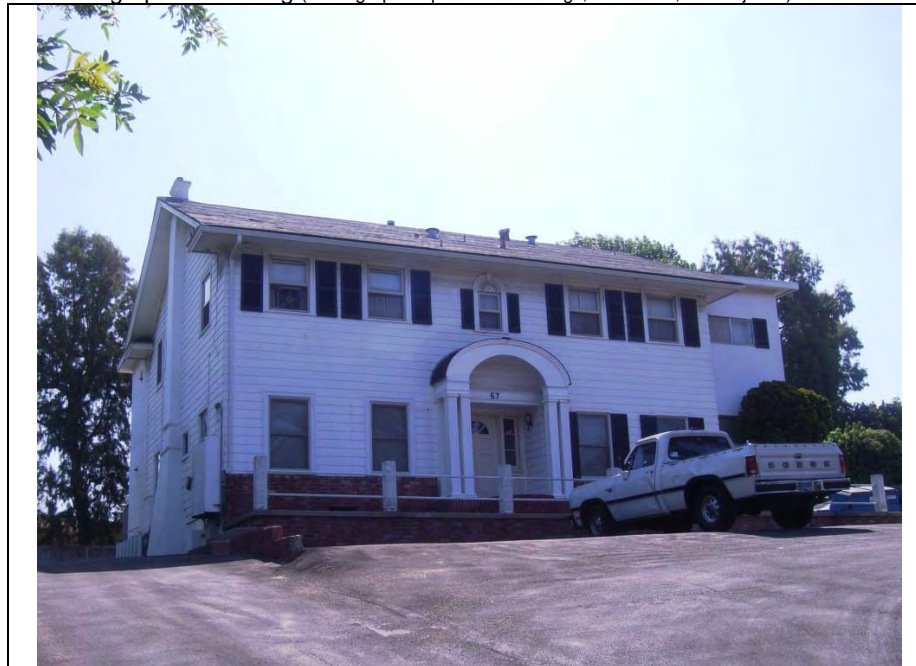
P5a. Photograph or Drawing (Photograph required for buildings, structures, and objects.)

View looking east at the building.

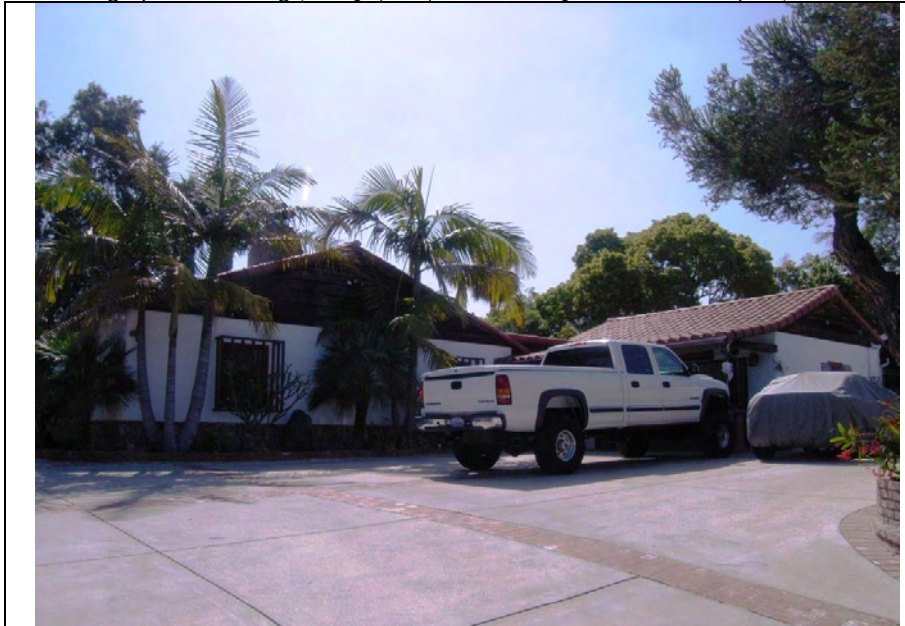
P5a. Photograph or Drawing (Photograph required for buildings, structures, and objects.)

View looking east at the building.

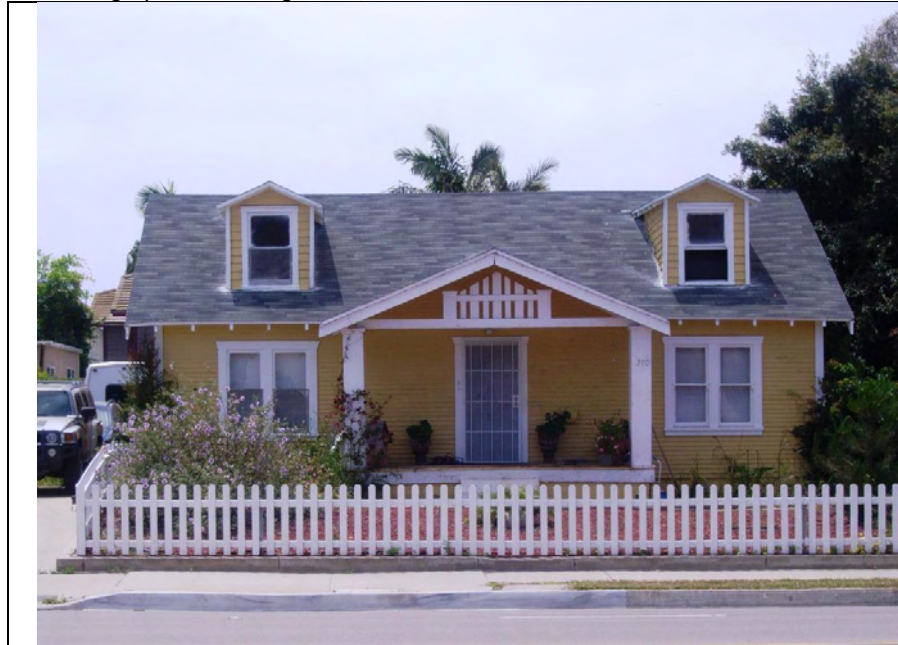
P5a. Photograph or Drawing (Photograph required for buildings, structures, and objects.)

View looking south at the building.
